> Experience feedback

Focus on an event notified to ASN through vigie-radiotherapie.fr

Avoiding a positioning error during kV-kV imaging

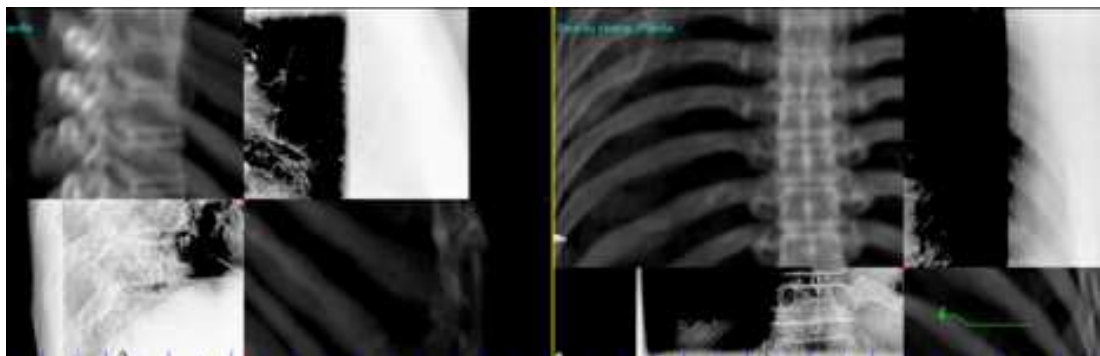
Repositioning is carried out by checking the alignment of the spinous processes (see picture below).

During the first 6 to 10 sessions, a positioning error of 2.5 cm occurred longitudinally (head to feet).

Verification of the positioning of a patient through the registration of a DRR and a kV image (side view (left) and anterior-posterior view (right))
